# Your Inspection Report

Inspection Date **9/28/2005**

<b>Full VIN:</b> 1GKFK66U21J265696	<b>Year:</b> 2002	<b>Engine Cylinders:</b> V8 OHV 16V
<b>Mileage:</b> 57215	<b>Make:</b> GMC	<b>Engine Lifters:</b> 6.0L
<b>Transmission Type:</b> Automatic	<b>Model:</b> Yukon Denali XL	<b>Engine Type:</b> Gas

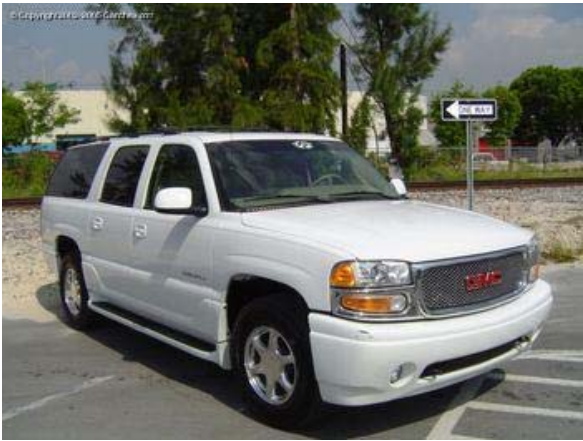
Inspection Area:	Overall Rating:
<b>Body</b>	<b>Excellent</b>
<b>Glass</b>	<b>Excellent</b>
<b>Wipers</b>	<b>Excellent</b>
<b>Tires &amp; Wheels</b>	<b>Excellent</b>
<b>Interior Items</b>	<b>Excellent</b>
<b>Gauges</b>	<b>Excellent</b>
<b>Audio System</b>	<b>Excellent</b>
<b>Carpet &amp; Upholstery</b>	<b>Good</b>
<b>Trunk</b>	<b>Excellent</b>
<b>Electrical System</b>	<b>Excellent</b>
<b>Under Hood</b>	<b>Excellent</b>
<b>Road Test</b>	<b>Excellent</b>
<b>Additional Inspection Points</b>	<b>Good</b>

The condition is excellent. There has been no body work or repainting done on the vehicle. There were minor pebble chips in the front bumper that were almost not visible. Other than that the paint and body are in excellent condition
